# Manhole Inspection Summary

Manhole # S53G\_\_027MH

Insp Date: **9/15/09 2:19 PM**

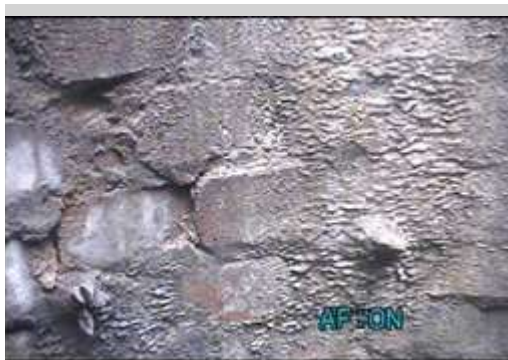
Defect 2

**Steps** Count: **5** Missing: **1** ☒ Corroded

missing & corroded rung

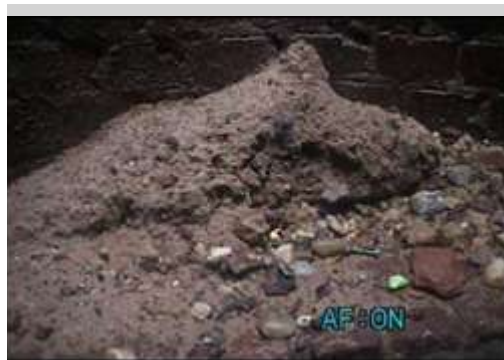
Defect 1

Condition: ☐ Sound ☐ Cracked ☐ Root Intrusion ☐ Deteriorated ☐ Leaks ☒ Debris

debris on the bench

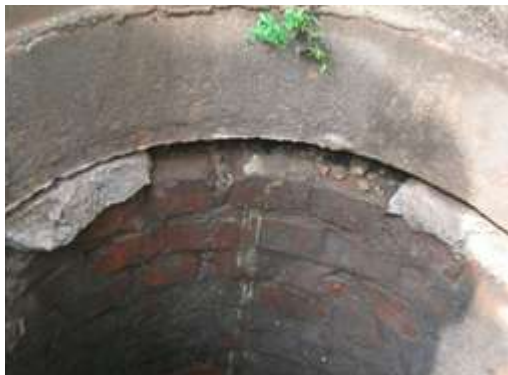
### Defect 3

Condition: ☐ Sound ☐ Cracked ☐ Root Intrusion ☒ Loose Brick ☒ Deteriorated

Infiltration: ☐ None ☒ Joint ☐ Cracks ☐ Mortar ☐ Roots ☐ Wall

deteriorated chimney with missing/loose brick & signs of infiltration

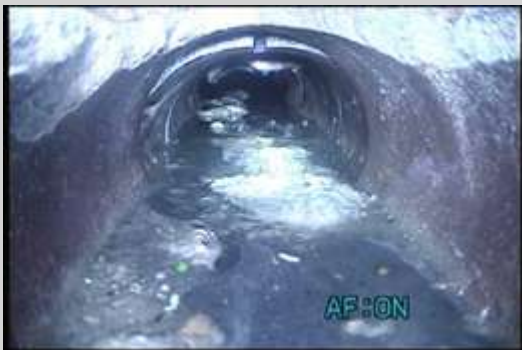
12 O'Clock Outflow

crown of pipe appears broken just outside of manhole

Deposits: ☐ None ☐ Mud ☐ Sludge ☒ **Debris** ☐ Grease

Silt Depth: **1** (in.) Deposits Extent: **Light**
